Assignment #5: Blower Door Analysis

By: Jesse Gadzinowski and Murat Kinaci, Students
Submitted To: Rory McDowall, Instructor, Humber College
Date: April 26, 2012
Subject: Final Test Hut Analysis

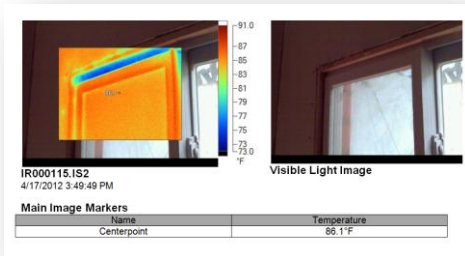
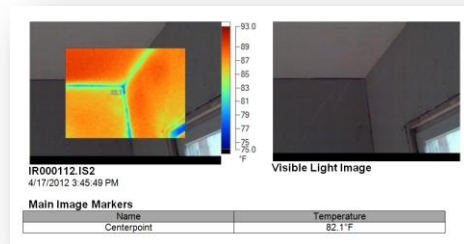
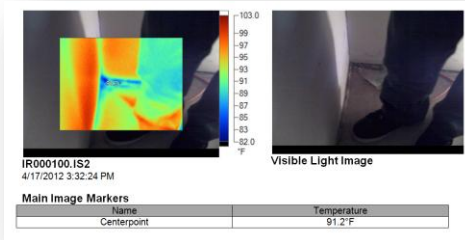
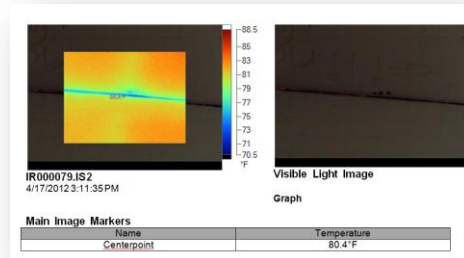
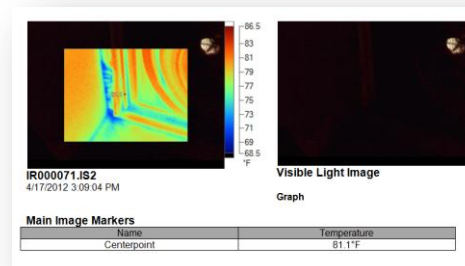
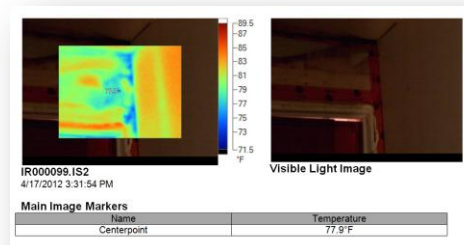
Observations of air flow using the smoke pencil and infra-red imaging camera revealed the highest leakage areas and least insulated areas in the hut. We found that points around the window and door were the least sealed, results of which were noticed using the smoke pencil. The infra-red camera allowed us to see insulation deficiencies mainly in the walls and corners of the hut, which were visible as blue sections in the pictures.

Based on our observations prior to drywall installation and infra-red analysis, there were some insulation deficiencies:

- Because we had limited time to work on this project and we were using recycled insulation material, our insulation job was not perfect.
- We also could not use the sealing foam effectively to seal the window and the door.
- Poor drywall installation caused unsealed corners and edges.
- Poor taping and trimming had also negative affect on our insulation.
- We did not do any finishing (mudding, painting, etc.)

Recalling the construction of the building itself, a few things could have been done to improve building performance. Finishing tape on all joints and seams would have created a better initial seal. Additionally, mudding the joints of the drywall with compound would have greatly increased the sealing capacity of the building corners. Using brand-new insulation would have increased the R-value of the walls; having an adequate supply of foam insulation for the window and door would have created a better enclosed space.
