ENERGY AUDIT: FIRE STATION 231

Prepared by: Shelby Kerbel, Murat Kinaci, Jesse Gadzinowski

Date: December 2, 2013

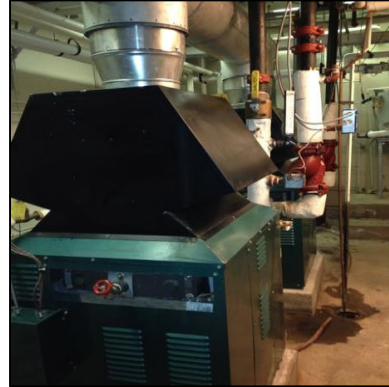
Primarily the central boiler plant located in the basement mechanical room provides heat for the building. This plant consists of two 512 kBtu atmospheric boilers rated at 82% efficiency; the boilers were installed approximately 10 years ago. Boiler specifications are referenced in *Appendix 11.2*.

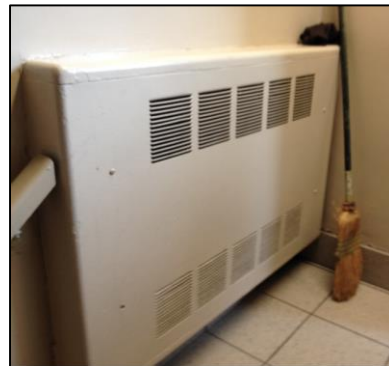
The boilers are piped as an injection loop in a primary/secondary loop configuration. Supply water temperatures and boiler staging are controlled by a digital controller, with supply water temperatures being re-set based on outdoor air temperatures. Each room, excluding washrooms and the main floor dispatch office, is equipped with baseboard radiators for heating. Baseboards are supplied with hot water through the building's primary loop and are controlled with wall-mounted dials that open or constrict the hot water valve. While these boilers are in good operating condition, they are older and running at a lower efficiency than current market alternatives.

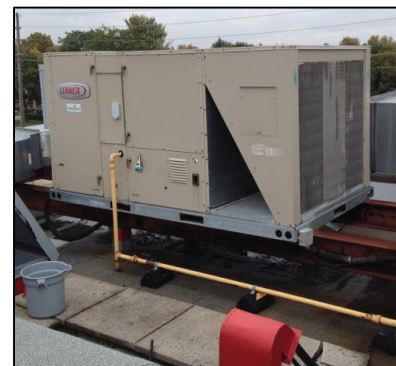
In addition to this, there are three separate packaged rooftop units, two for heating and cooling and one solely for cooling. The rooftop unit located above the dispatch office is intended to serve only that space. The first floor plan, found in *Appendix 11.1*, shows the location of this room. A thermostat located in the dispatch office controls heating and cooling into the space.

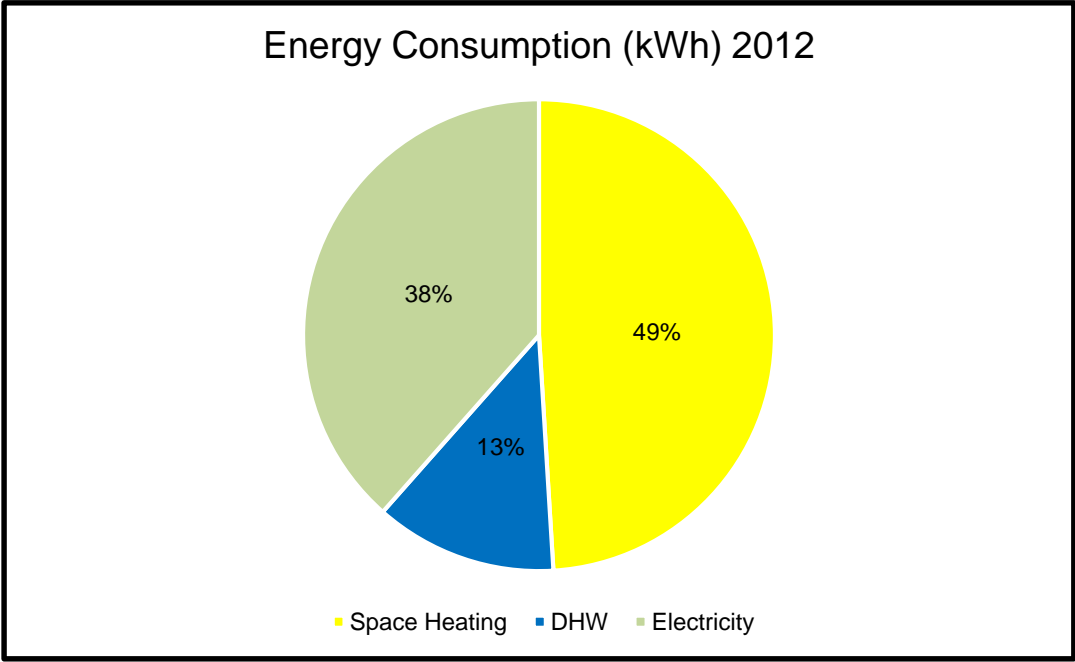
As can be seen below, electricity is the main energy consumption in the building, followed by space heating and then DHW.

Energy Consumption (kWh) 2012	
Space Heating	178,055
DHW	45,390
Electricity	139,742

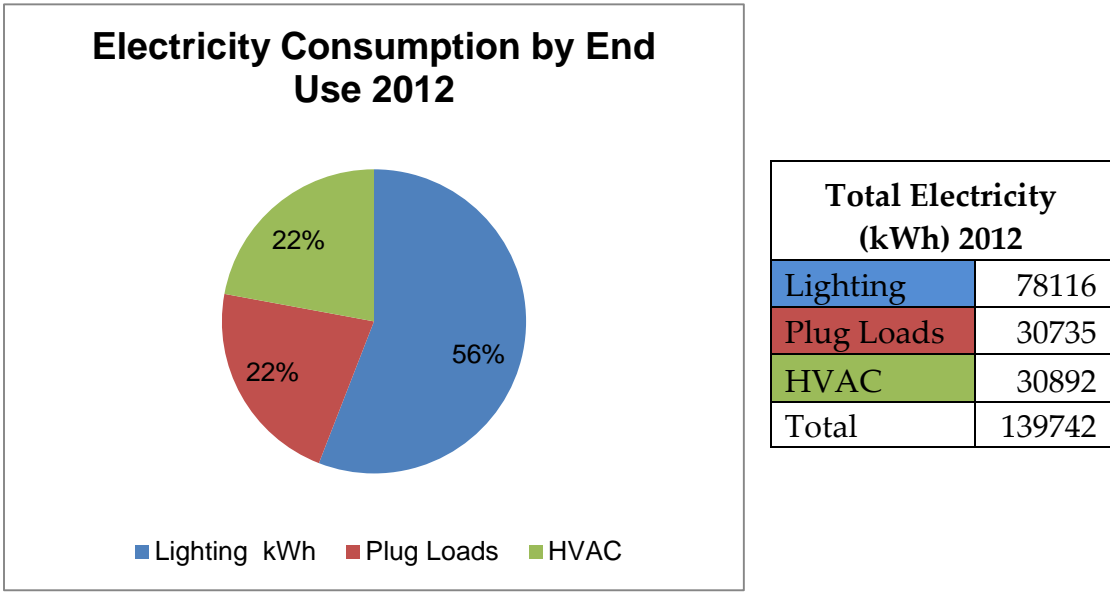
The chart below represents estimated electricity consumption by end use. By determining the power consumption and occupancy schedule of the station's plug loads and lighting we were able to determine the annual consumption of the building loads. Based on this chart, the most significant savings will be accomplished by retrofitting HVAC systems or components that directly impact HVAC performance. While HVAC yields the greatest opportunity for savings, measures for lighting and plug load efficiency will be recommended.

Lighting	78116
Plug Loads	30735
HVAC	30892
Total	139742

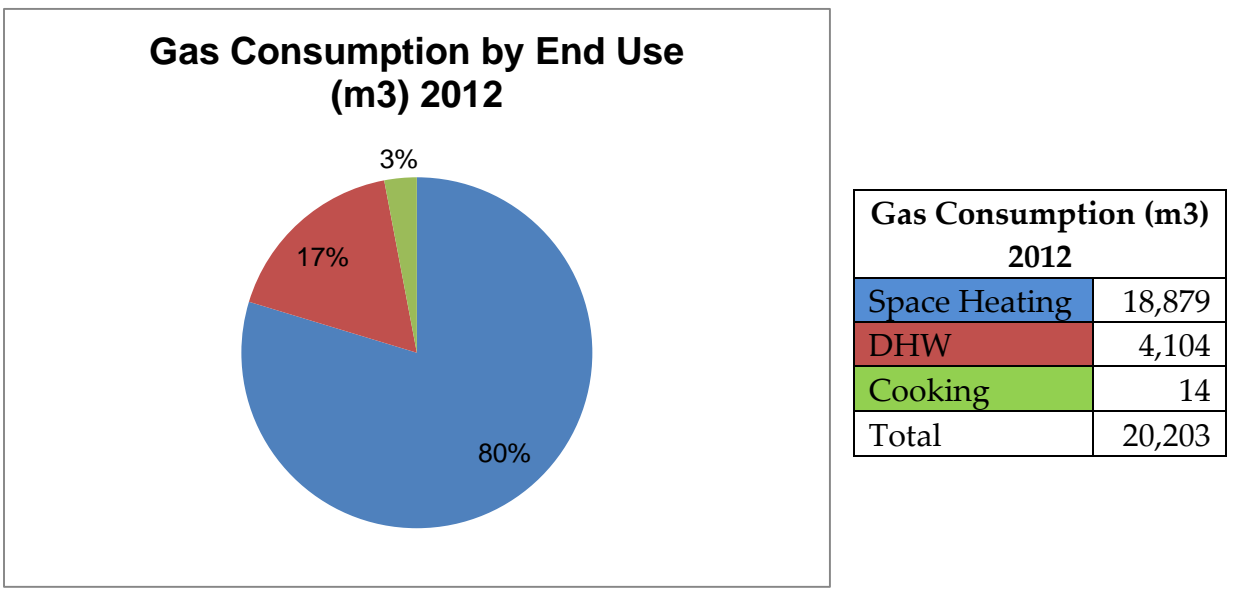
The chart below represents estimated gas consumption by end use. The annual consumption of the space heating, domestic hot water and cooking loads was determined by examining the power consumption of all systems, as well as the occupancy schedule of the station. The chart below indicates that the most significant savings will be accomplished by retrofitting the space heating systems.

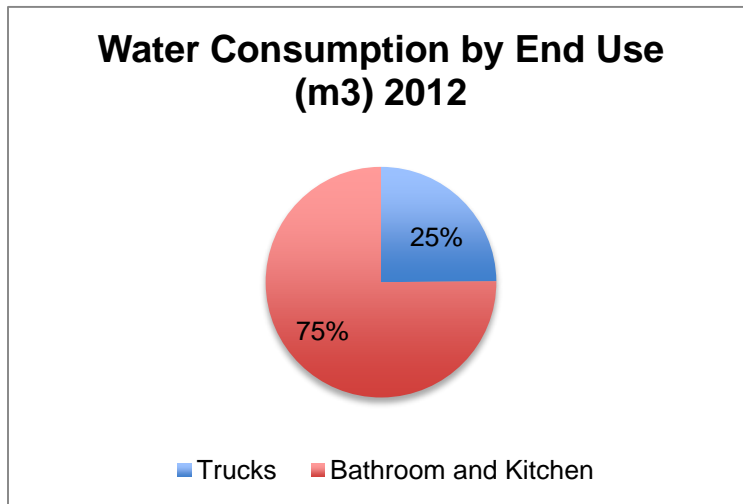
The chart below is a representation of the estimated water consumption by end use for the building. The end use consumption was determined by estimating the power consumption of both loads, as well as occupancy use. It is evident that the greatest water savings can be accomplished by retrofitting the bathroom and kitchen water consuming appliances/devices.

Water Consumption (m ³) 2012	
Trucks	240
Bathroom & Kitchen	725.3
Total	985.3

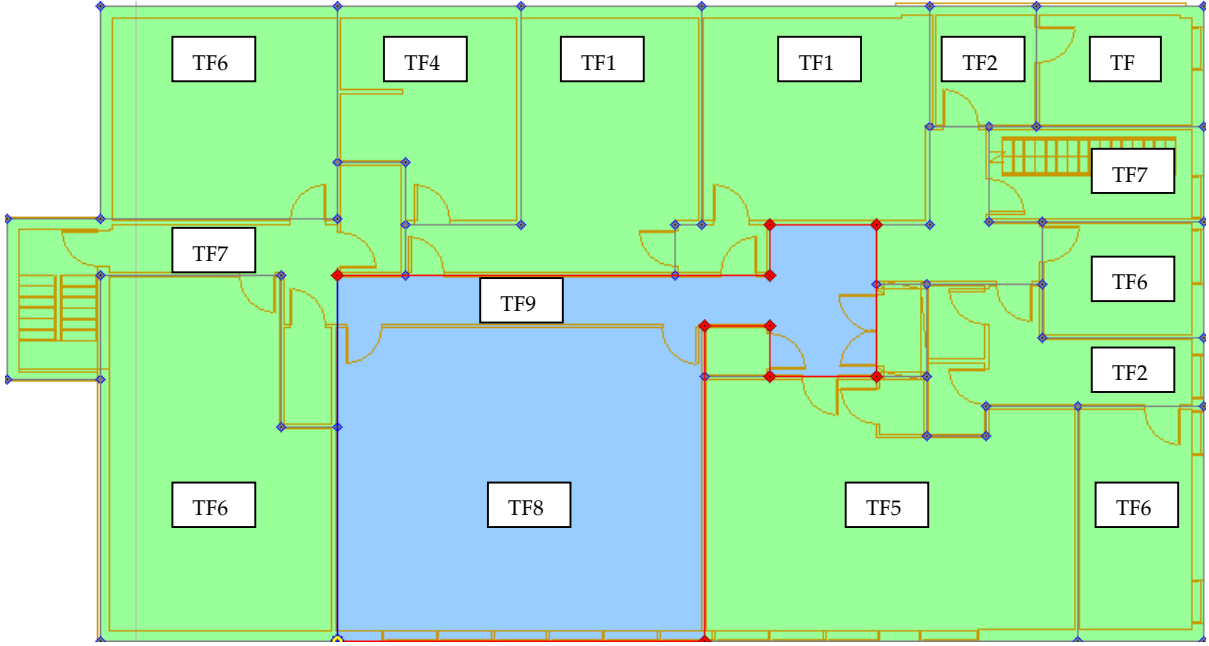
3rd Floor Zoning

Zone #	Third Floor Zones	Zoning Rules			Selection Basis
		Same HVAC	Same Function	Same Loads	
TF1	Gym	Yes	No	No	HVAC
TF2	Office	Yes	No	No	HVAC
TF3	Restrooms	Yes	Yes	Yes	HVAC
TF4	Changeroom/Lockers	Yes	Yes	Yes	HVAC
TF5	Kitchen	Yes	No	No	HVAC
TF6	Bedrooms	Yes	No	No	HVAC
TF7	Corridor	Yes	No	No	HVAC
TF8	Living Space	Yes	No	No	HVAC
TF9	Corridor	Yes	No	No	HVAC

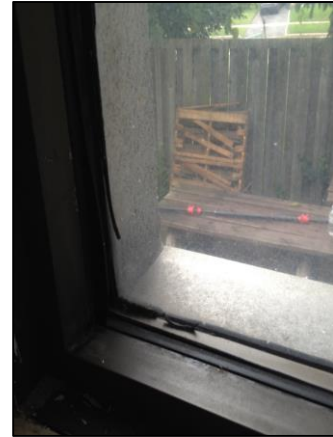
During the site visit it was noted that the seal on a number of windows were in poor condition requiring new weather stripping. Weather stripping is one of the most cost effective retrofit options available in terms of window renewal. Simple payback for weather stripping is less than 2 months with annual savings of \$820.

Weather stripping can be applied by the city's internal maintenance work force, FRED, and should be reapplied every 5 years. Annual weather stripping inspections are recommended to maintain optimal conditions of all windows and doors.

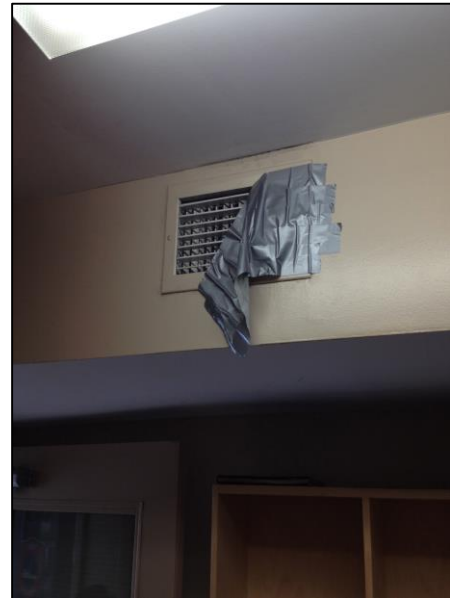
It is highly recommended that a system that balances air-flow and distributes treated air uniformly be installed. It is also highly recommended that heat recovery ventilators be installed on each floor, regardless of the payback considerations as a means for supplying fresh air during the heating season. Heat recovery ventilators capture some of the energy from the exhaust air and pretreat the fresh make up air increasing indoor air quality, which was evidently a significant issue in the building.
